Crescenta Valley Dog Park

Introduction

Crescenta Valley Dog Park is a community initiated addition to an existing County park (Crescenta Valley Park) located in the Los Angeles suburb of La Crescenta. Meeting the needs of the community and finding opportunities to protect and restore the environment are priorities in the design and programming of our parks. This project demonstrates these principles; it retains and cleanses stormwater, recharges the groundwater, conserves water and uses energy from renewable sources. At the same time, it creates a balanced approach to accommodating dog owners in public open space, by providing a place to socialize and exercise dogs in a safe environment. It brings people together through their common interest creating a greater sense of community in the park as a whole.

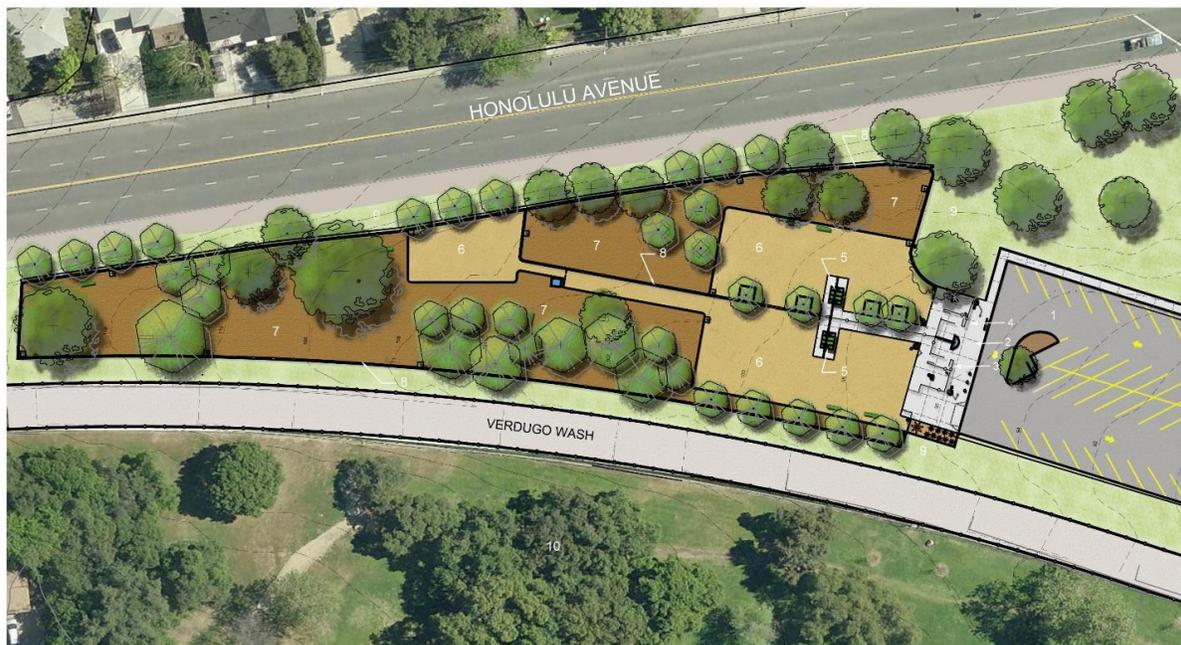
CRESCENTA VALLEY DOG PARK: SITE PLAN

SITE AMENITIES

1. PARKING LOT
2. DOG PARK ENTRANCE, INCLUDES:
MONUMENT SIGNAGE
REGULATION SIGNAGE
DOG WASH
COMMUNITY BULLETIN BOARDS
BICYCLE RACKS
SOLAR LIGHTING
3. LARGE DOG DOUBLE GATED ENTRY, INCLUDES:
ADA, REGULAR AND DOG DRINKING FOUNTAIN
4. SMALL DOG DOUBLE GATED ENTRY, INCLUDES:
ADA, REGULAR AND DOG DRINKING FOUNTAIN
SHADED ADA BENCH
5. SHADED ADA BENCH
6. DECOMPOSED GRANITE AREA, INCLUDES:
BENCHES AND WASTE RECEPTACLES
7. CEDAR CHIP AREA, INCLUDES:
BENCH
8. FENCING
9. PLANTING AREA
10. CRESCENTA VALLEY PARK

The dog park features include: a half acre small dog area and a one-acre large dog area with separate double gated entrances. Each is completely fenced and has large areas of permeable decomposed granite surfacing. Other features include: a dog wash outside the entry gates; drinking fountains for owners and pets; benches in both areas, some with shade structures; and security lighting, as well as areas of cedar chip surfacing under and around the mature trees. The cedar chips material is non-toxic and is a natural flea and fly repellent, the use of this "built-in" pest control prevents the growth of flea population and provides a clean and comfortable environment for both dog and owner.

Sustainable elements were incorporated into the project design. With the exception of concrete walkways all the surfacing is permeable. The site is graded to retain all stormwater on site, recharging the groundwater keeping pollutants from the flood channel. Surface and subsurface drainage devices and prefab dry wells retain all overflow. Other water conserving measures include the use native or drought tolerant plant materials and the irrigation controller is weather-based. Benches and shade structures are 90% recycled material, and both the LED security lighting and the irrigation are solar powered. Additional native sycamore trees were added to improve the habitat, mitigate heat, provide more shading, and sequester carbon dioxide.
